Maintenance and Efficiency Plan

7635 Lucky Lane
Seattle, WA

A0208091958

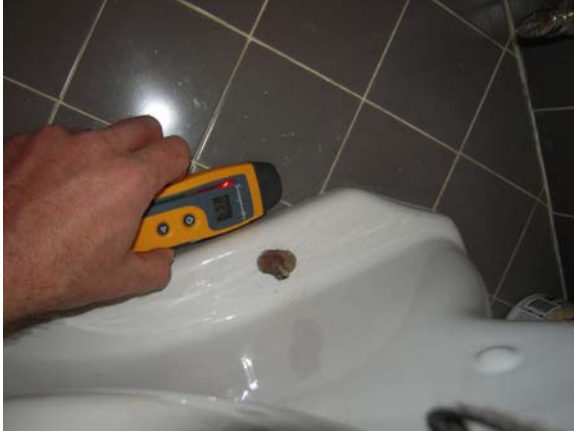
The left side shows high moisture meter readings at the master bath toilet. The right side shows the clogged drain on the family bath shower that requires repair.

- Re-set the master bath toilet that is leaking below the floor and replace this toilet with a low flow or even dual flush toilet.
- Improve attic access by installing an access in the hallway or a closet in the back of the home.

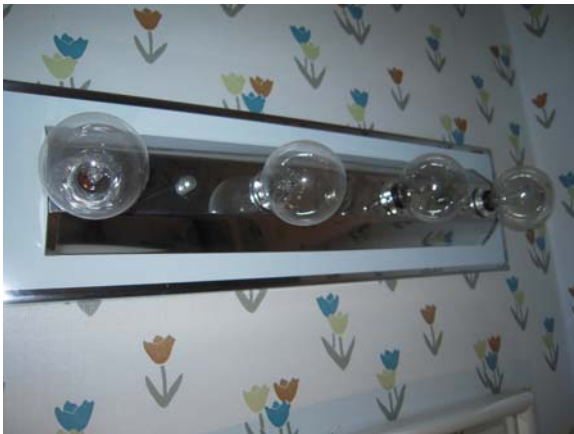
The left side shows an obsolete light fixture that uses much more energy than necessary. Updating to Energy Star fixtures would be logical. The right side shows a more urgent repair: to replace the failing roof. This shows high moisture meter readings at the soffit.

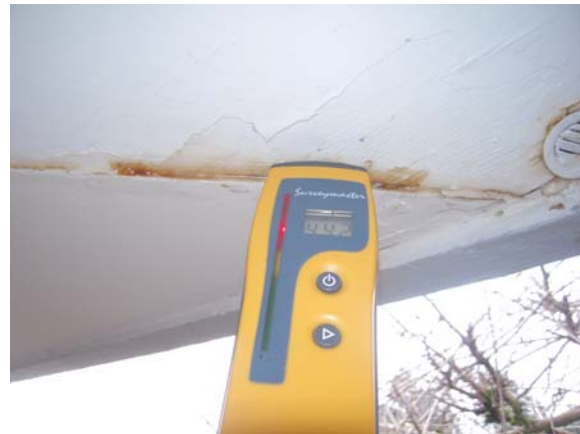
- The major concerns from a maintenance standpoint are essentially:
 1. Localized failure was noted at the eaves and built-in gutter system and lots of amateur and vulnerable details were noted in the flashings and field of the sloped roof.

- Hire a licensed roofing contractor to replace this roof. As you have a low slope roof with built in gutters, you have several options. I strongly recommend a complete tear off and re-roof. Consider using a PVC membrane for the whole roof or at least the built-in gutter system. I would increase the size of the scupper drains as well for improved reliability of the drainage system. When the main roof is removed, be sure to evaluate the roof deck and water damage at the eaves as several soft spots were noted and there is lost of water staining around the eaves. If you choose to do shingles again, make sure proper precautions are made for a low slope shingle installation.

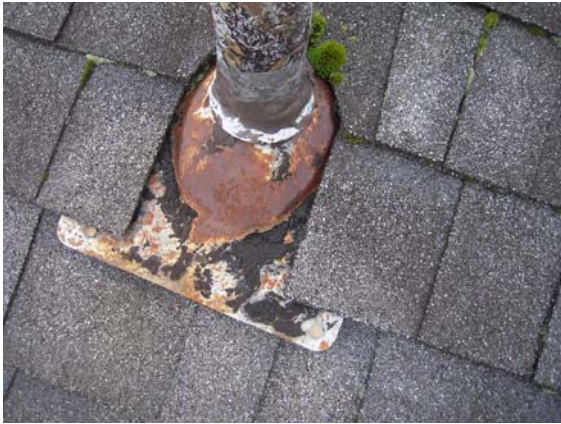
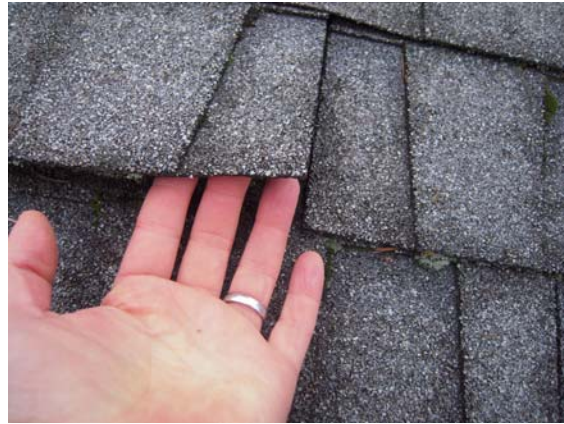
These both show vulnerable details to the roof: corroded and damaged flashing boots and loose shingles. The loose shingles is especially concerning on a low-slope roof.

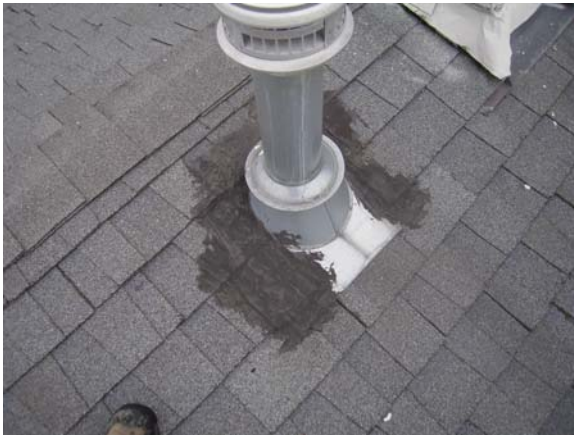
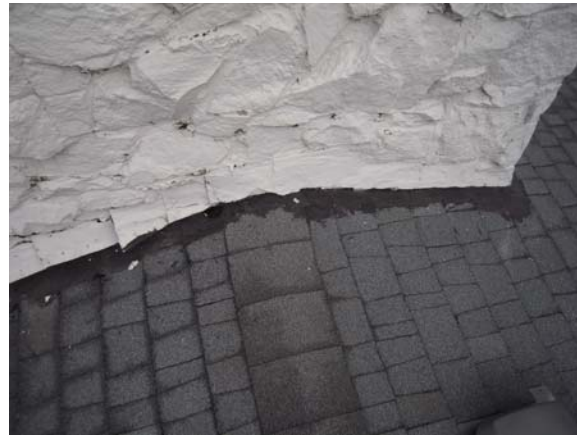
These show more vulnerable flashing details as well as amateur workmanship.

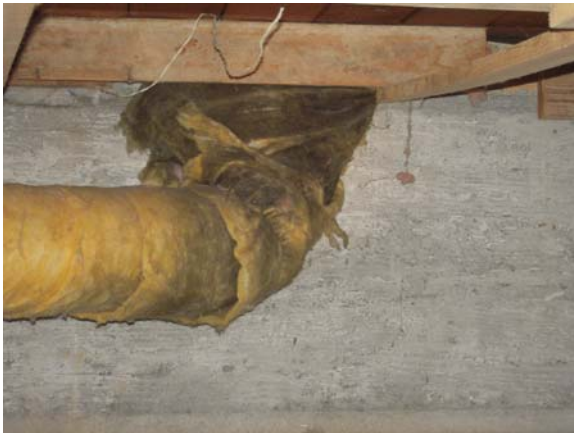
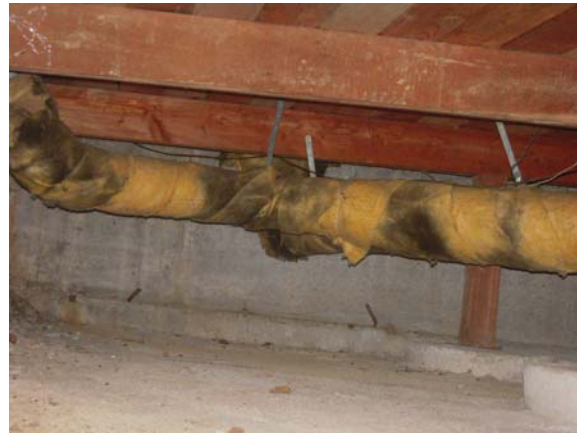
These two photos show leaking heat ductwork in the crawl space. Paybacks for air sealing this ductwork are fantastic. This repair should be done ASAP to save energy and money.

- Air seal all ductwork with duct mastic and insulate to R-8 or better.
